# Manhole Inspection Summary

Manhole # S15C1\_018MH

Insp Date: **5/28/08 12:34 PM**

**Location** Address: **1801 inverness av**

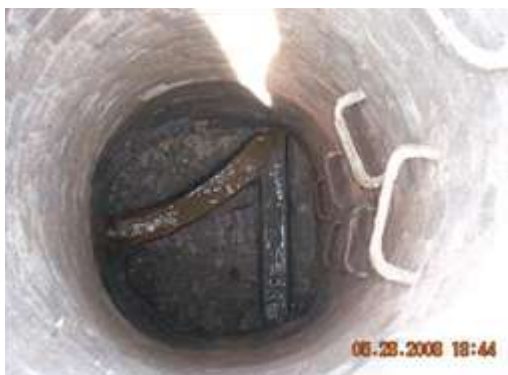
bench debris

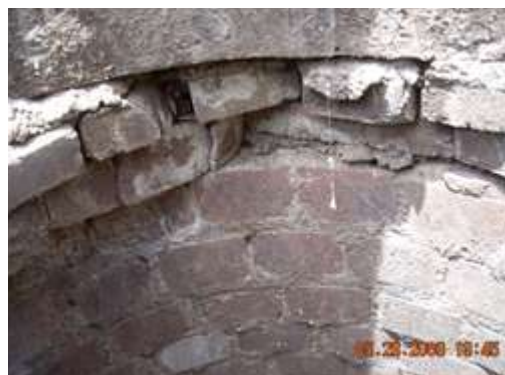
Defect 4

Condition: ☐ Sound ☒ **Cracked** ☐ Root Intrusion ☐ Loose Brick ☐ Deteriorated

cracked chimney bricks

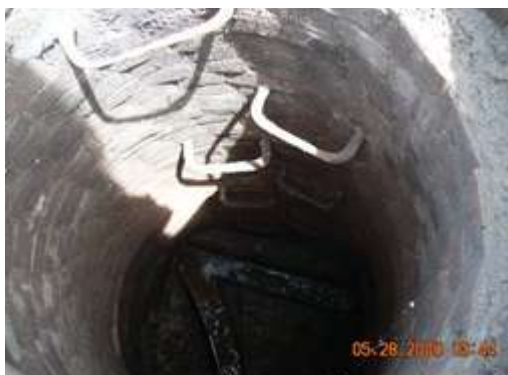
Defect 3

**Steps** Count: **7** Missing: **0** ☒ **Corroded**

corroded steps

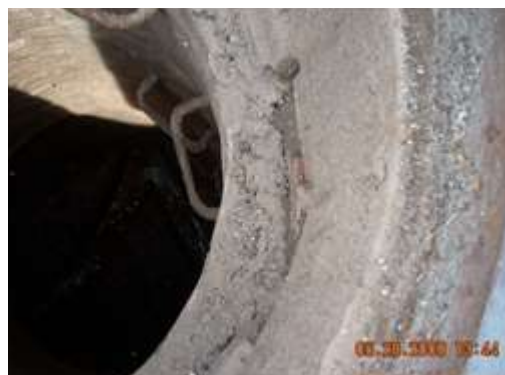
Defect 2

**Frame** Offset: **2** (in.)

frame offset

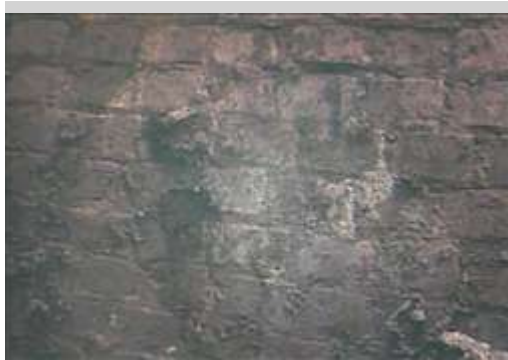
Defect 1

Infiltration: ☐ None ☐ Joint ☐ Cracks ☐ Mortar ☐ Roots ☒ **Wall**

infiltration @ barrel wall

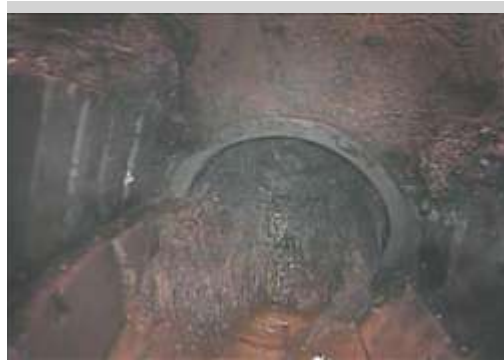
Defect 5

Condition: ☐ Sound ☐ Cracked ☒ **Root Intrusion** ☐ Deteriorated ☐ Leaks ☐ Debris

roots blocking pipe channel

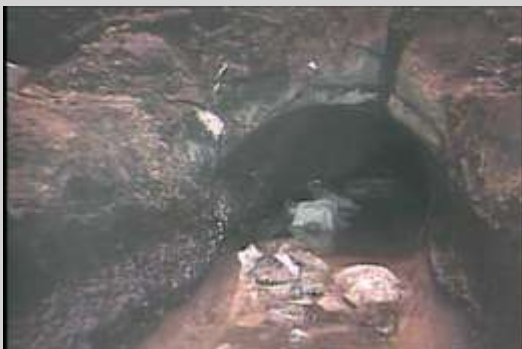
6 O'Clock Inflow

Pipe Height: **8.4** (in.) Rod and Bar (Angled)  
Pipe Material: **Clay** ☐ Pipe Lined  
Invert Depth: **12.20** (ft.) Flow Characteristics: **Slow**  
Deposits: ☐ None ☐ Mud ☒ **Sludge** ☒ **Debris** ☐ Grease  
Silt Depth: **3** (in.) Deposits Extent: **Medium**  
Infiltration: **Evidence** Pipe Seal Cond: **Broken**

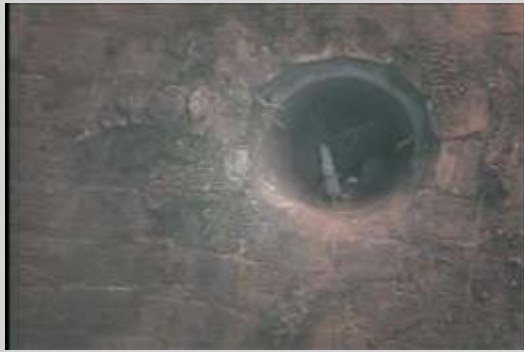
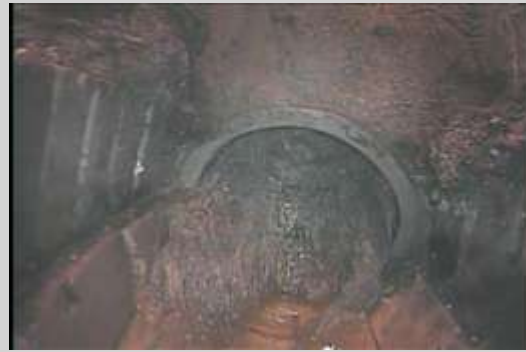
9 O'Clock Inflow

roots blocking pipe channel

Deposits: ☐ None ☐ Mud ☐ Sludge ☒ **Debris** ☐ Grease

Silt Depth: **7** (in.) Deposits Extent: **Heavy**

Infiltration: **None** Pipe Seal Cond: **Roots**

Drop Condition: **Partly Clogged**
